Greenbelt Project 983

Achieve a 50% Reduction In Forklift Truck Related Incidents (Damage to Plates)

Roger Rustom MIIRSM

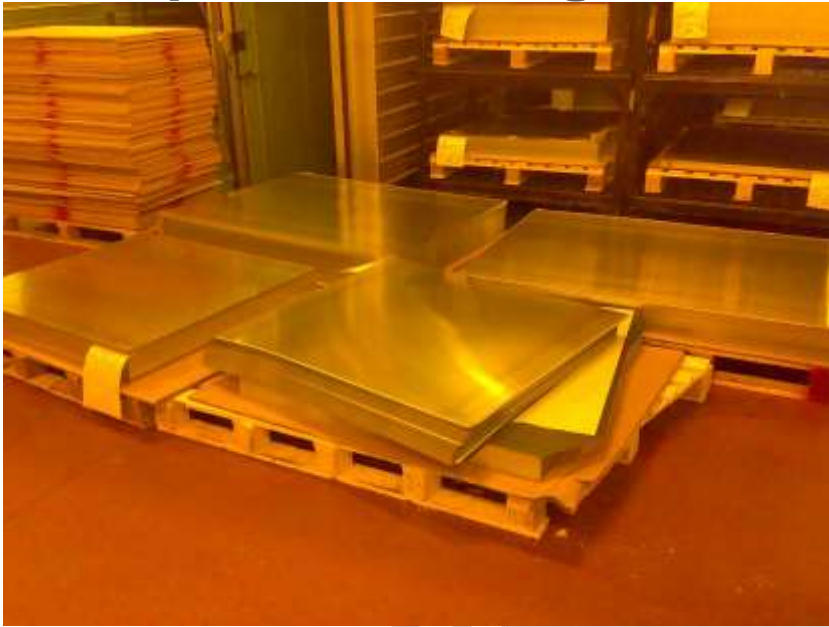
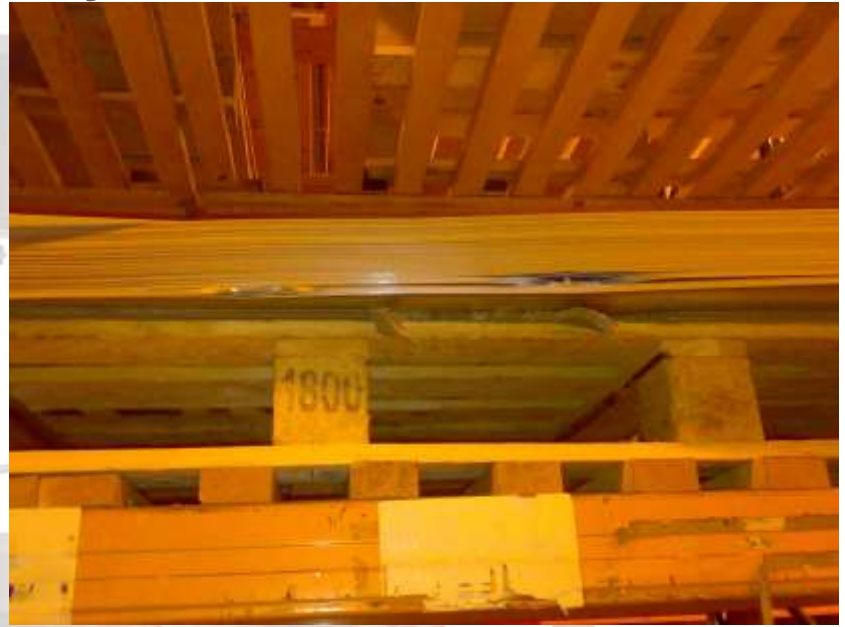
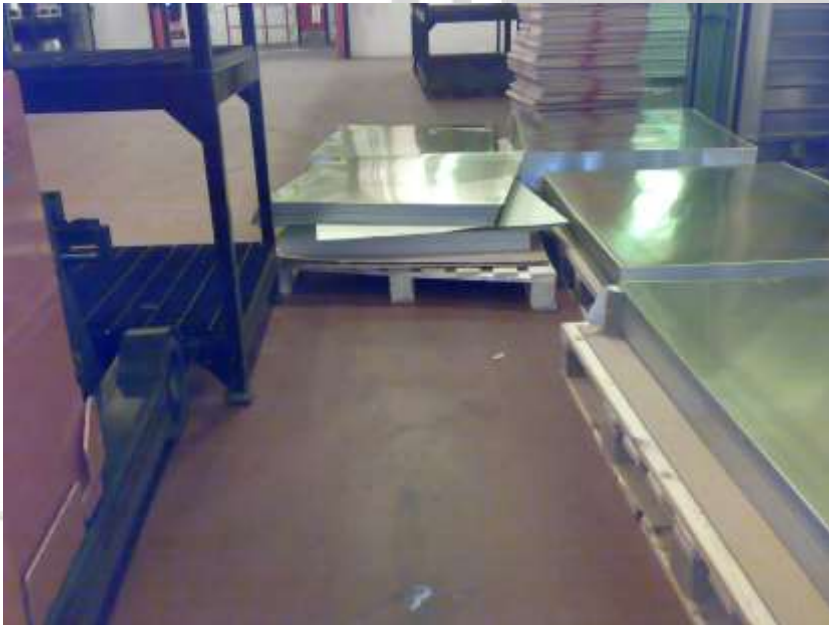
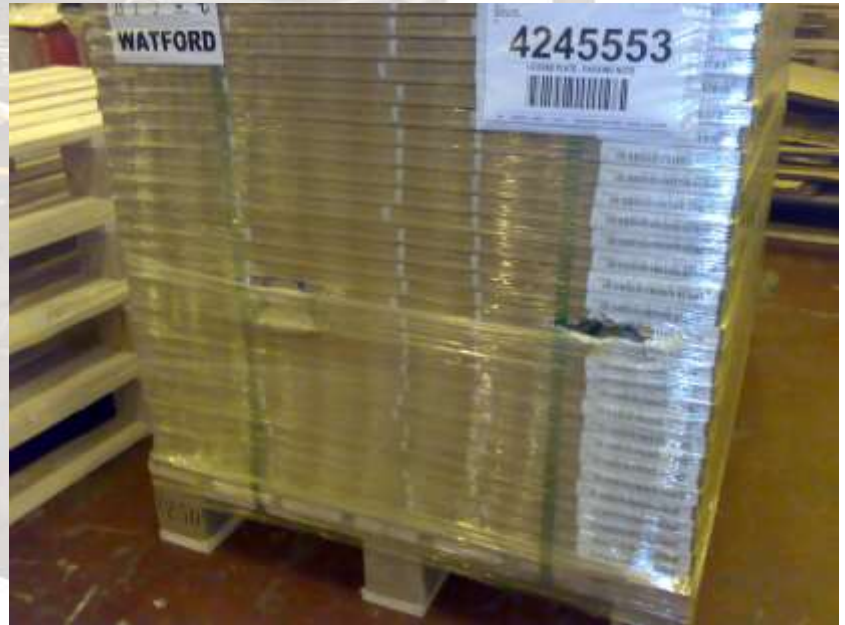
Examples of damage caused by Forklift Trucks

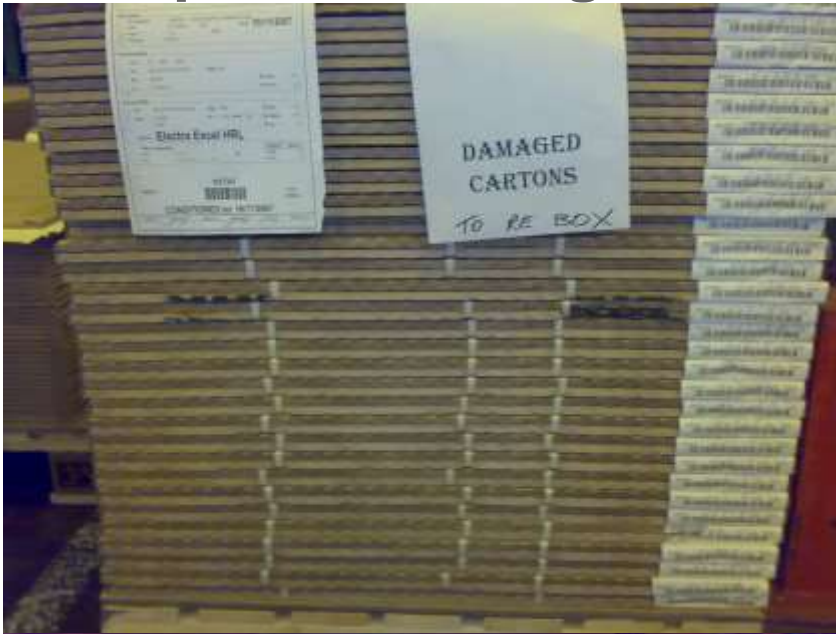
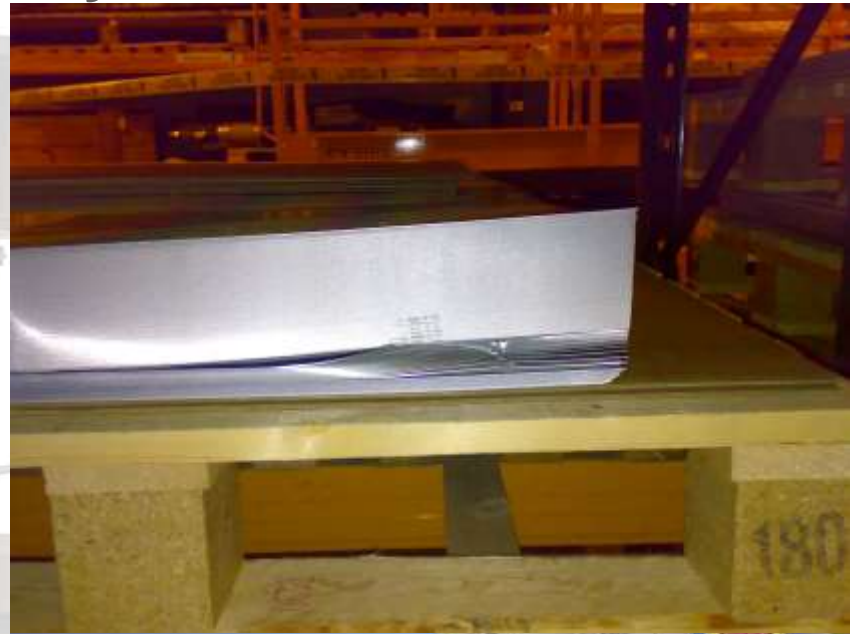
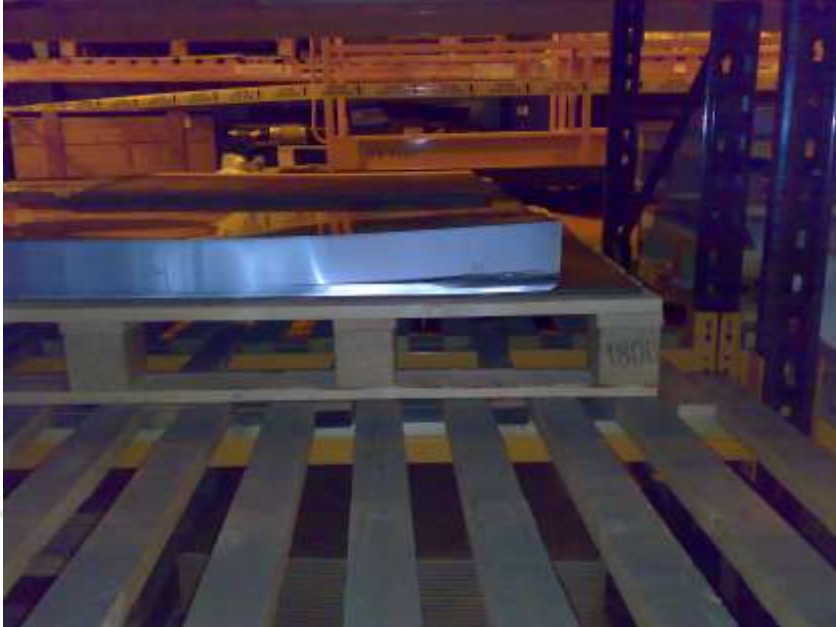
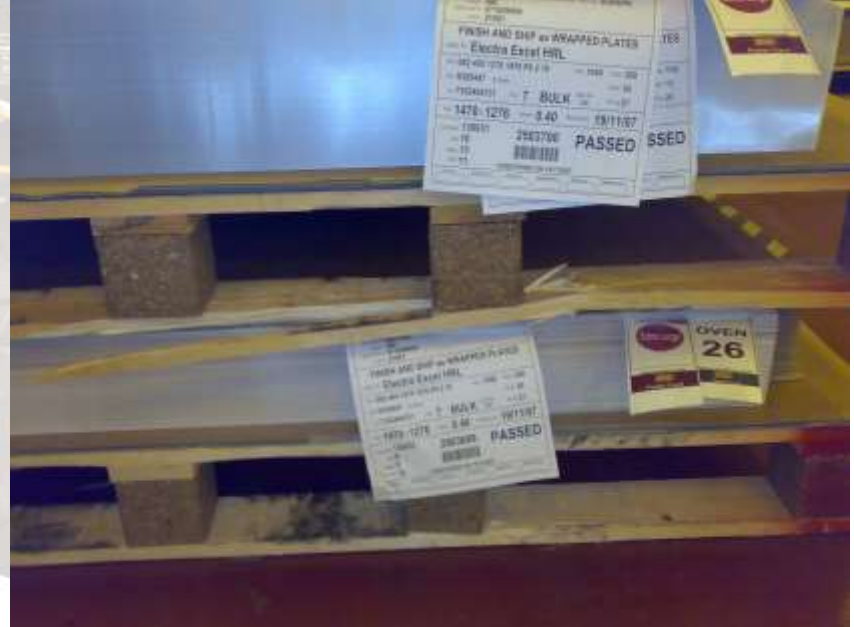
Examples of damage caused by Forklift Trucks

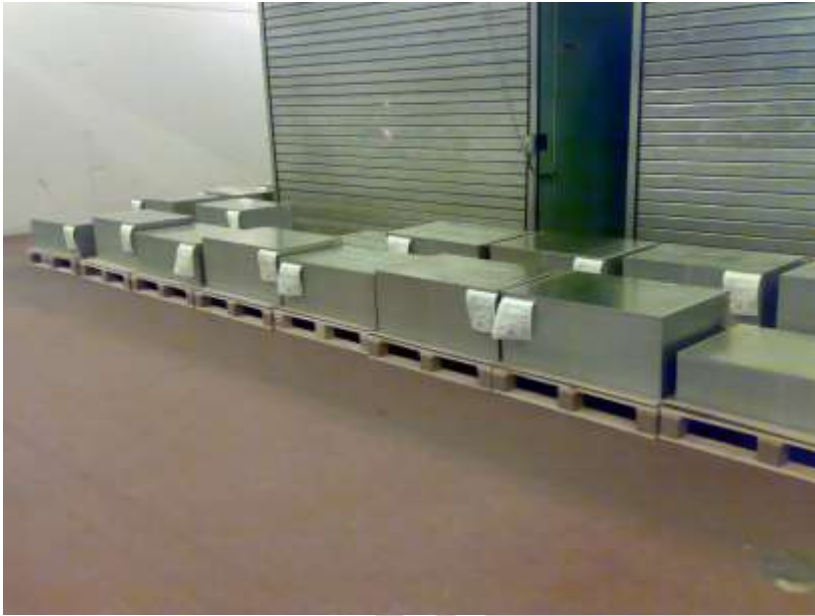
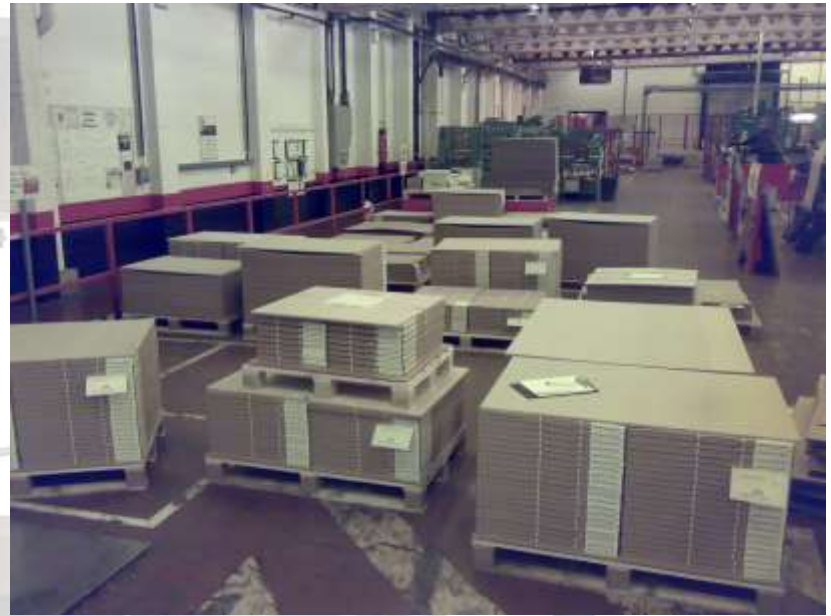
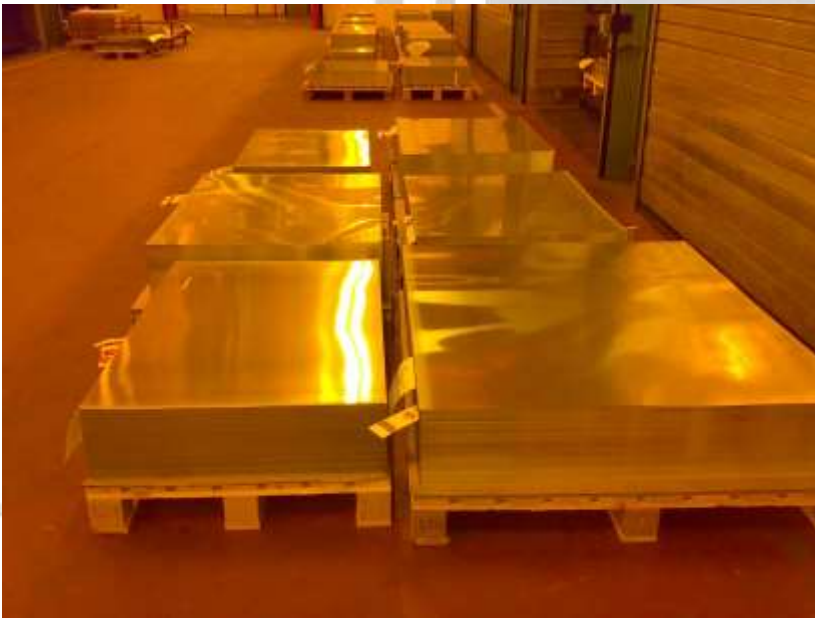
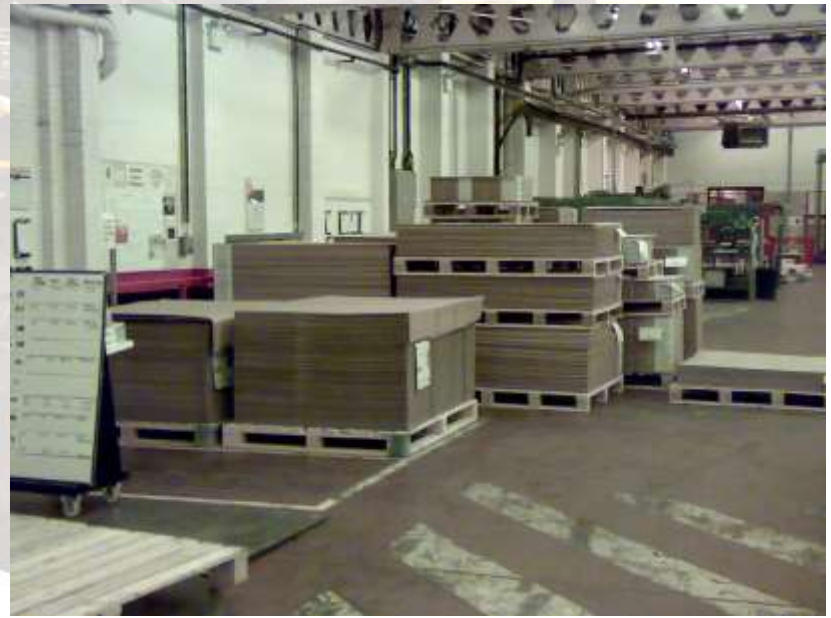
Opportunities for Forklift Truck damage to occur

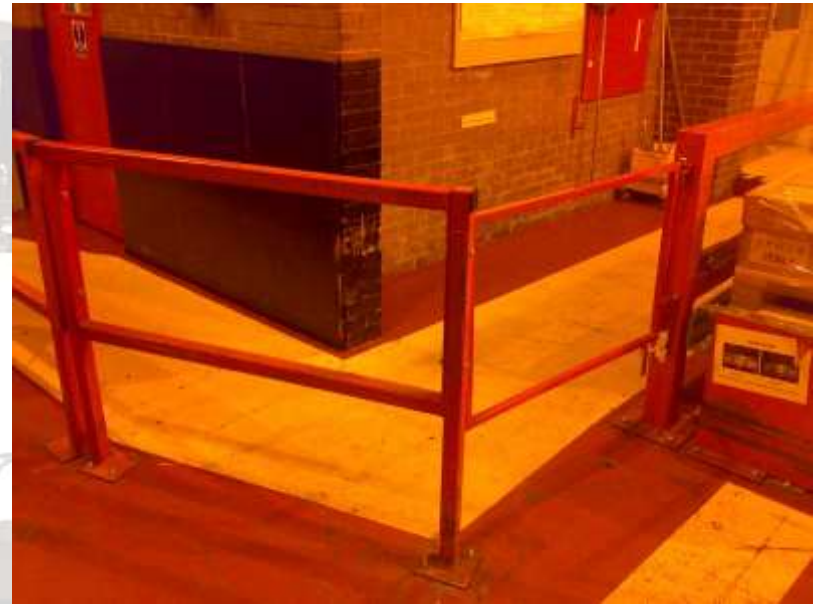
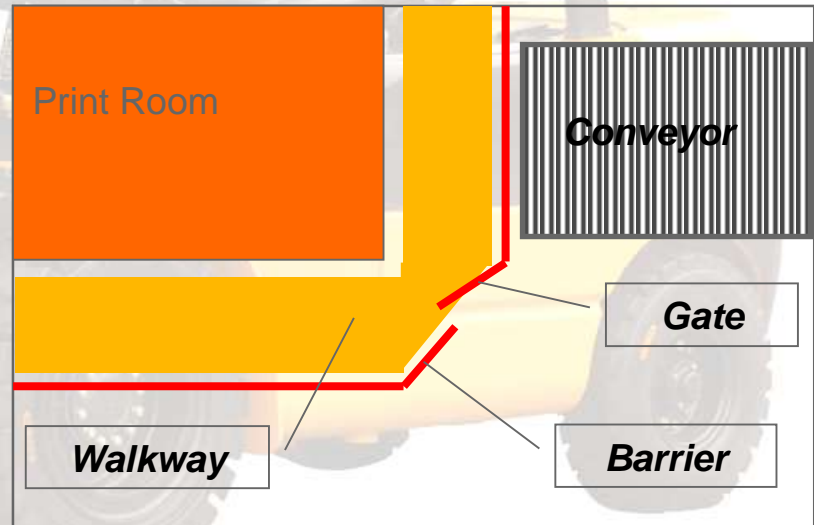
Barrier Alteration – Quick Win

- The position of this barrier means that it gets clipped on a regular basis when moving pallets by the end of the conveyor
- Angle the barrier more to improve the access to the conveyor area and to modify the gate accordingly (both low cost modifications). This reduces the likelihood of damage to plates due to better access to the end of the conveyor
