A STUDY OF MAN-MACHINE / MACHINE-MACHINE INTERFACE

PROACTIVE STRATEGY OF ACCIDENT ELIMINATION

AT QS036 – P02A

EARTH WORK

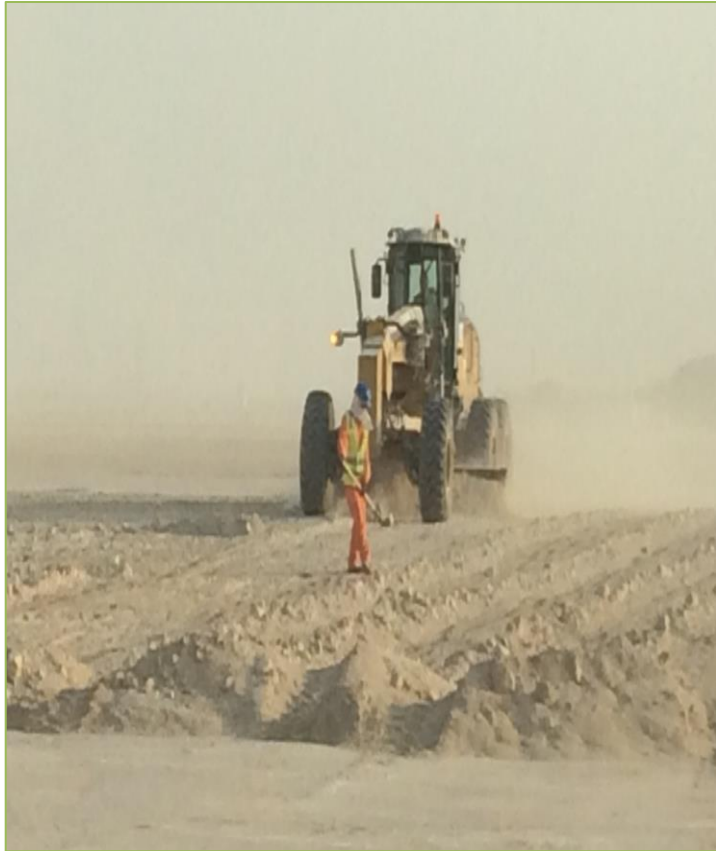
MAN – MACHINE INTERFACE

Workers were doing manual filling of the surface while the grader is in operation towards his direction. No supervisor and banksman to caution the other worker of the approaching grader.

A full time competent supervisor has to be deployed to look after this kind of activity as it was observed that workers are inattentive of the incoming equipment and the operator as well continues to drive towards the worker's direction.

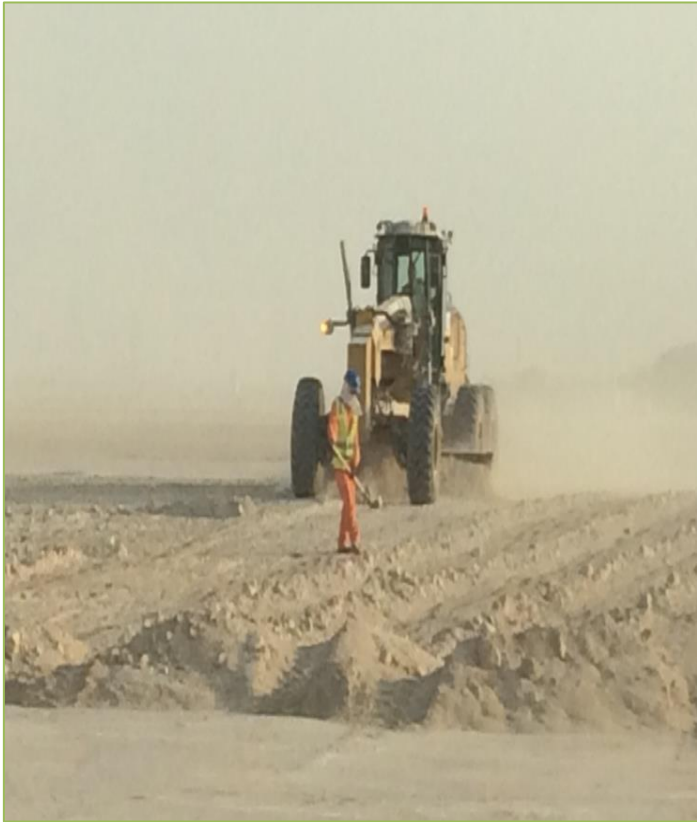
MAN – MACHINE INTERFACE

Workers were doing manual filling of the surface while the grader is in operation towards his direction. No supervisor and banksman to caution the other worker of the approaching grader.

A full time competent supervisor has to be deployed to look after this kind of activity as it was observed that workers are inattentive of the incoming equipment and the operator as well continues to drive towards the worker's direction.

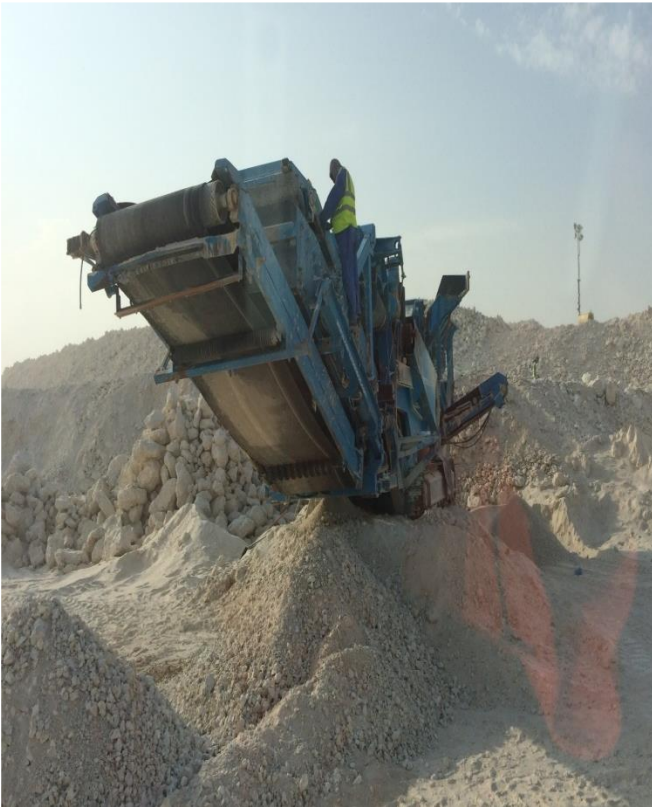
MAN – MACHINE INTERFACE

Crusher workers doing maintenance to the machine (at heights) without sufficient platform and not even wearing any fall protection such as full body harness, workers are also not having dust mask and not into complete mandatory PPE requirements at site.

Installation of working platform may not be practicable for this activity, therefore recommend that full body harness must be worn during maintenance work of the crusher. Close supervision must be ensured during this activity as worker was seen neglecting safety rules (failure to use PPE and dust control system was not observed).

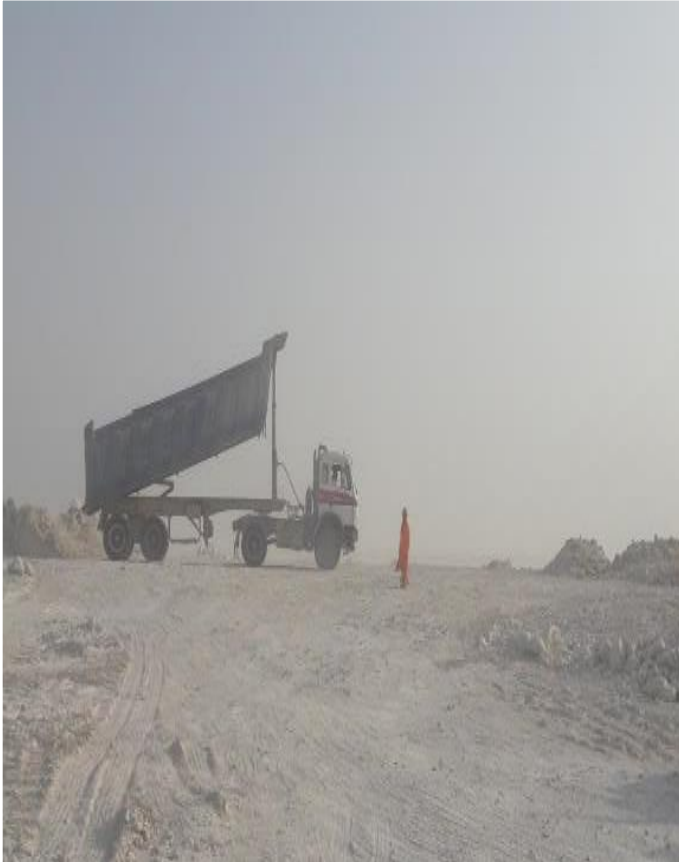
MAN – MACHINE INTERFACE

Material unloading practice is acceptable. The flagman guides and directs the reversing truck to the drop point and ensure the evenness and stability of the unloading area. The flagman moves away from the truck, positioned himself at the side where he will see the driver and gives the signal to start unloading.

Though the procedure has been implemented acceptably with this activity, it was noted that the drivers were going out of the trucks without the mandatory PPEs. It was recommended that PPE compliance level shall be monitored closely. All employee on site must be supplied with mandatory PPE (Helmet, reflective vest, safety shoes and safety glasses).

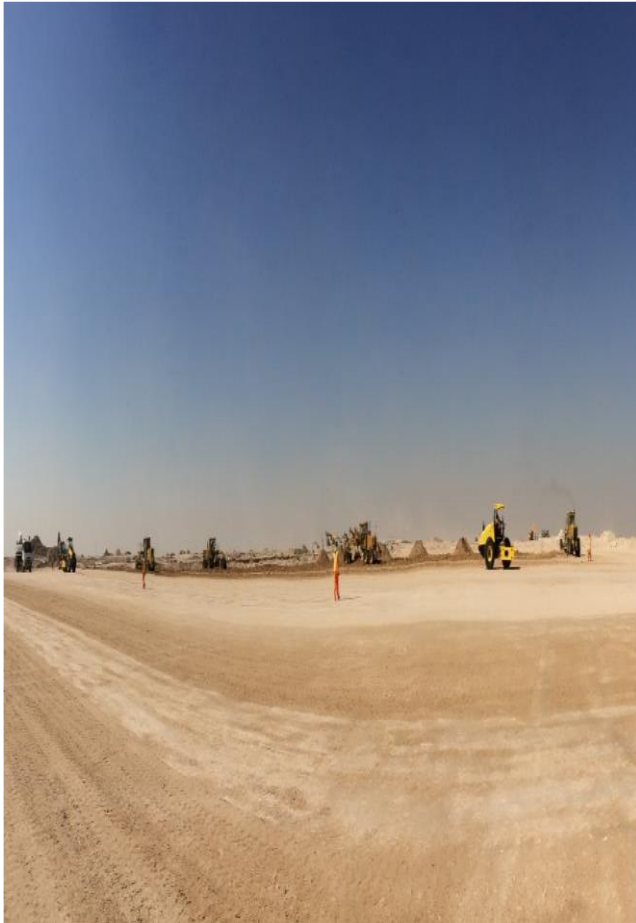
MACHINE – MACHINE INTERFACE

Grading and compaction activity with the use of heavy equipment is observed to be at the low-risk level as the area is wide enough to give sufficient distance among moving graders and compactors. Interview conducted on site with the operators at the location indicated that the hazards and control measures of the work activities are discussed on daily basis during pre start briefing.

This practice has to be maintained and supervisor for this activity has to be in close supervision.

GEC will audit randomly to verify that the situation at the work area has not changed and that control measures are effective.

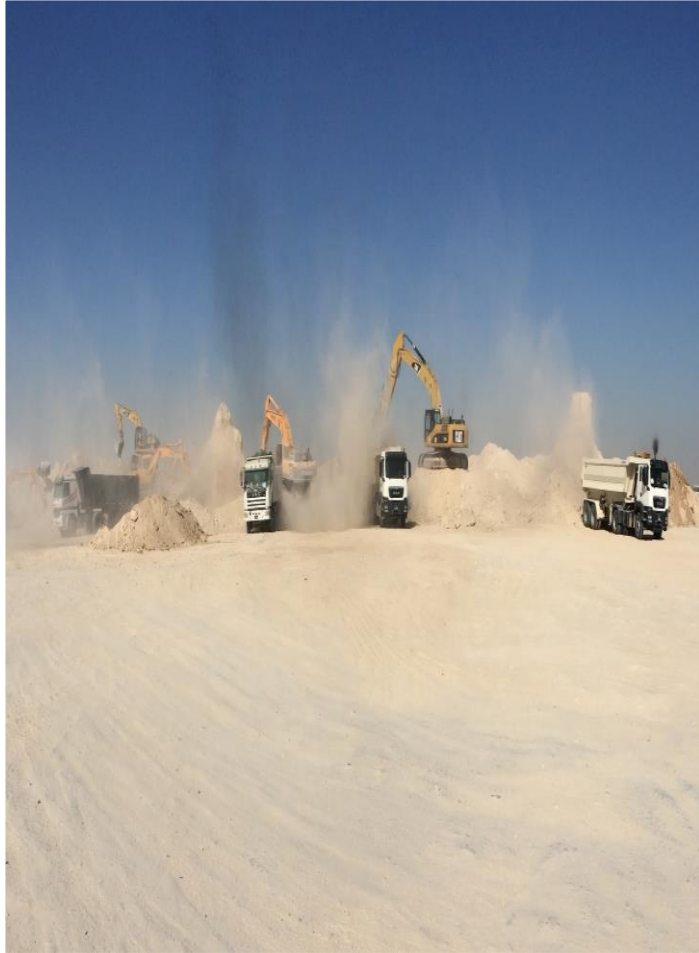
MACHINE – MACHINE INTERFACE

Loading of backfilling materials to trailer trucks by backhoe are kept in a safe working distance both the backhoe and trucks. Slewing radius are also maintained at a proper gap to avoid collision.

This good practice has to be maintained, however the recommendation include ensuring that contractor improve on the truck route demarcation and proper visibility using dust damping system.

Also one-way system as it was observed that incoming and outgoing trucks are not having identified route should be changed.

Lastly, the use of banksman is discouraged as the number of equipment and the visibility are issues to be controlled.
